HOWARD NEEDLES TAMMEN AND BERGENOFF NEW YORK  
CHESAPEAKE CITY BRIDGE. BRIDGE INSPECTION REPORT NUMBER 118.(U)  
DEC 79

REPORT DOCUMENTATION PAGE		READ INSTRUCTIONS BEFORE COMPLETING FORM
1. REPORT NUMBER	2. GOVT ACCESSION NO.	3. RECIPIENT'S CATALOG NUMBER
4. TITLE (and Subtitle) Bridge inspection report no 11B, Chesapeake City Bridge, Maryland		5. TYPE OF REPORT & PERIOD COVERED Bridge Inspection report no. 11B, Contract report 1979

The findings and recommendations for the 1979 inspection of the Chesapeake City Bridge (Route designation, U.S. Route 213) which crosses the Chesapeake and Delaware Canal was undertaken for the Department of the Army, U. S. Corps of Engineers by Howard Needles Tammen & Bergendoff (HNTB) and are submitted herein. A location map is presented in Drawing 1-0.

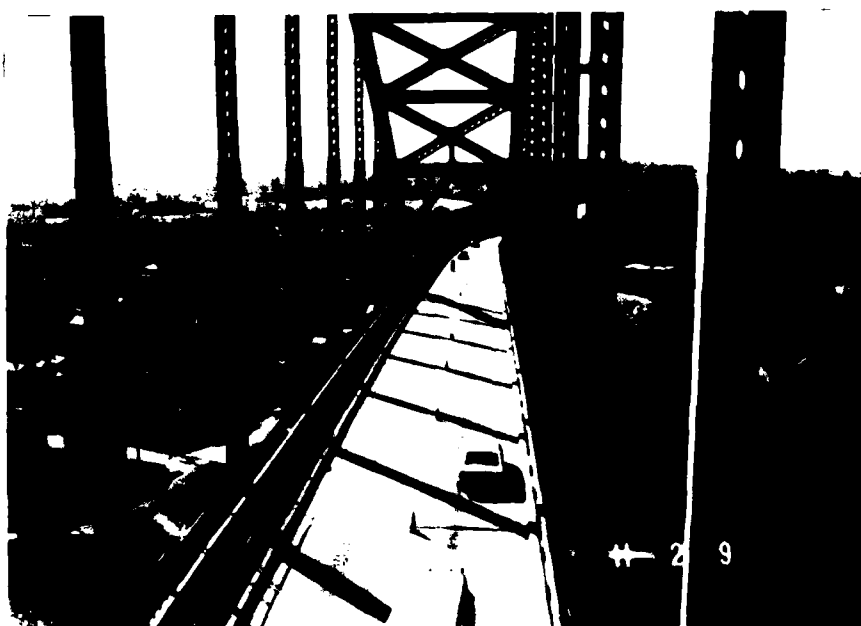
Photograph 2 - Roadway view, looking south through arch span.

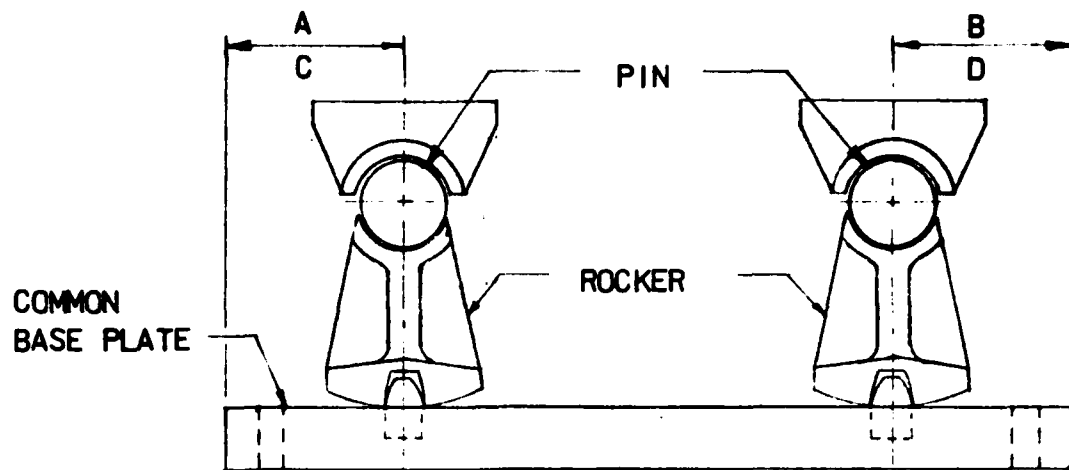
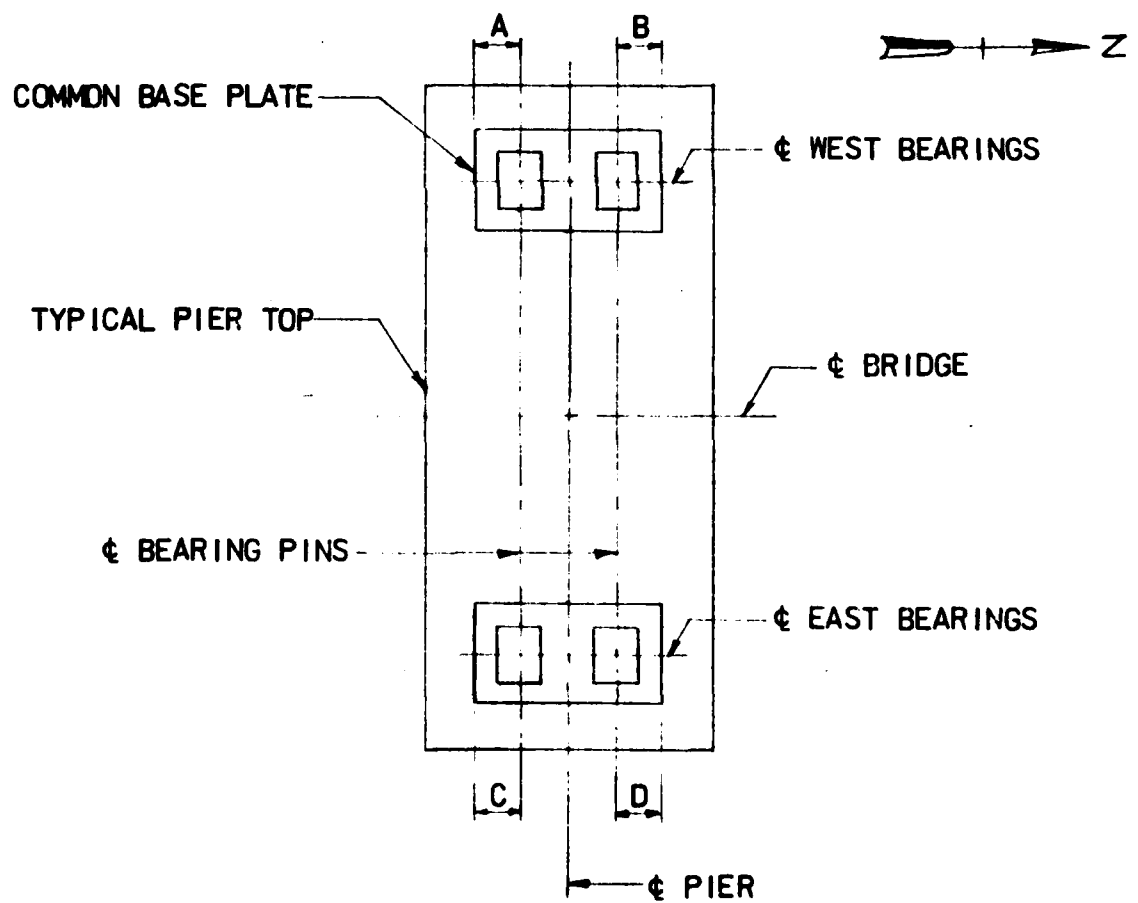
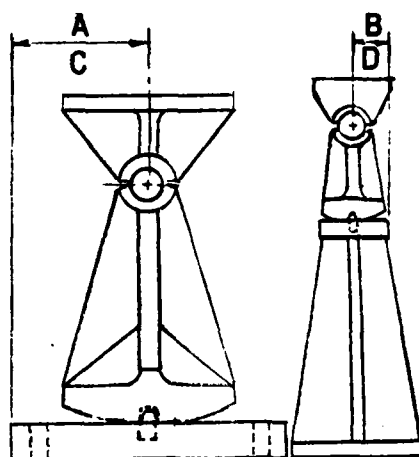
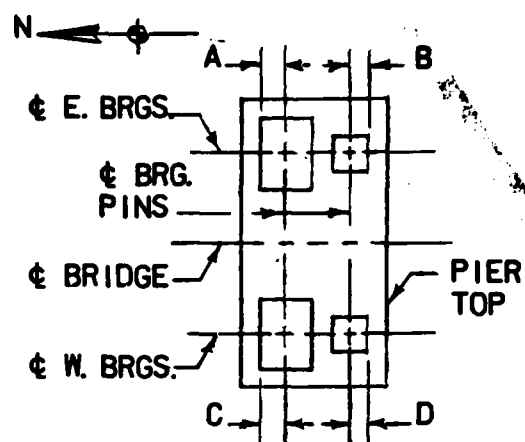
EXPANSION ROCKER BEARING ALIGNMENT MEASUREMENTS					
DATE	TEMP.	OFFSET DISTANCES (INCHES)			
		A	B	C	D
MAY 1973	74°	23 $\frac{7}{8}$	5 $\frac{5}{8}$	23	5 $\frac{1}{2}$
MAY 1975	77°	23 $\frac{7}{8}$	6 $\frac{7}{8}$	23 $\frac{7}{8}$	6 $\frac{15}{16}$
OCT. 1979	48°	23 $\frac{3}{4}$	6 $\frac{5}{8}$	23 $\frac{5}{8}$	6 $\frac{3}{4}$
